St Augustine's Church Survey Report

Grahame Park

3.1 Structure and Concrete survey

This inspection was carried out on 20th May 2020. Concept Consultancy. John Brown. See Appendix 1.

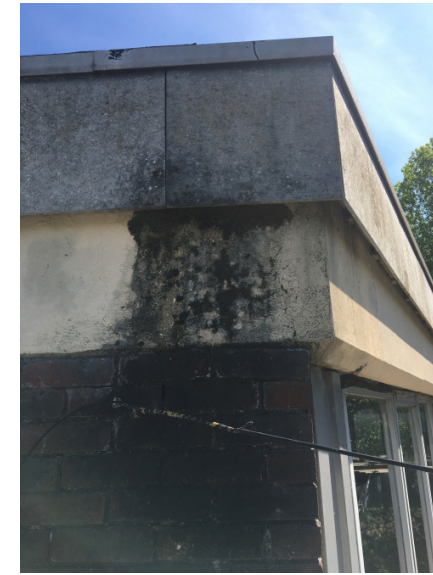
The main ring beam on the SW corner. The discoloured concrete indicates overflowing gutters and has led to spalling fabric and exposure of the steel reinforcement

We would also recommend that any spalling concrete is removed and the reinforcement treated. The concrete can then be repaired with a suitable repair mortar. The structure of the building is a cast in-situ concrete frame. The main building is based on an irregular hexagonal frame with columns at each corner carrying the cill beam to clerestory windows, and roof beam at eaves level above. Intermediate columns are expressed internally on the inner panels.

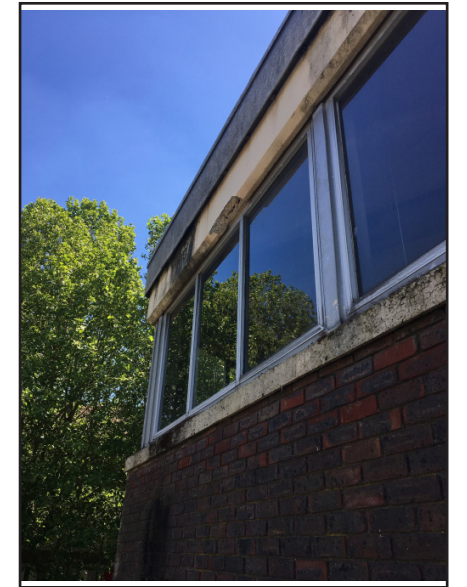
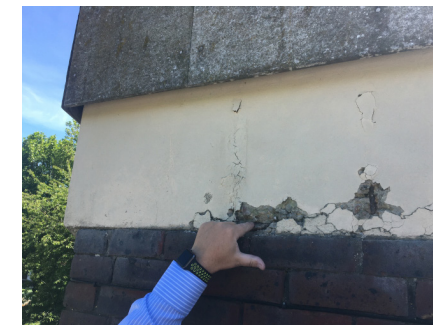
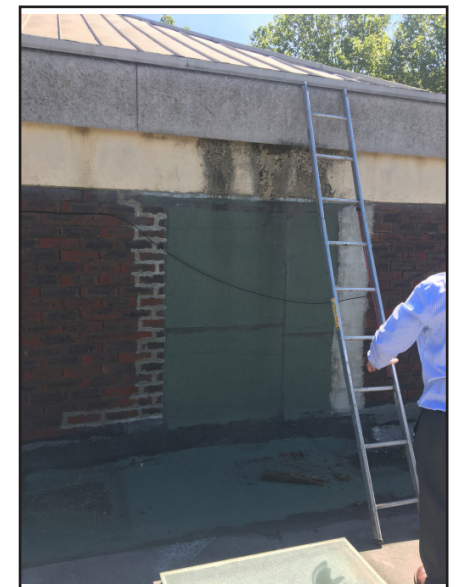
The ring beam shows signs of water damage and concrete spalling exposing the steel reinforcement

"The carbonation, sulphate and chloride results were all very low which is good. There was only one instance where the carbonation was greater than the reinforcement cover. The main issue with the beams is low cover. However this is localised to small areas. The water run off from the roof is coming down edge of the beams in several locations. This is where the steel corrosion is worse. The Survey recommend that the roof and drainage design is modified so that the water run off can be directed away from the beam edge.

We would recommended contacting Sika. They can specify a specification and what repair materials are most suited. "

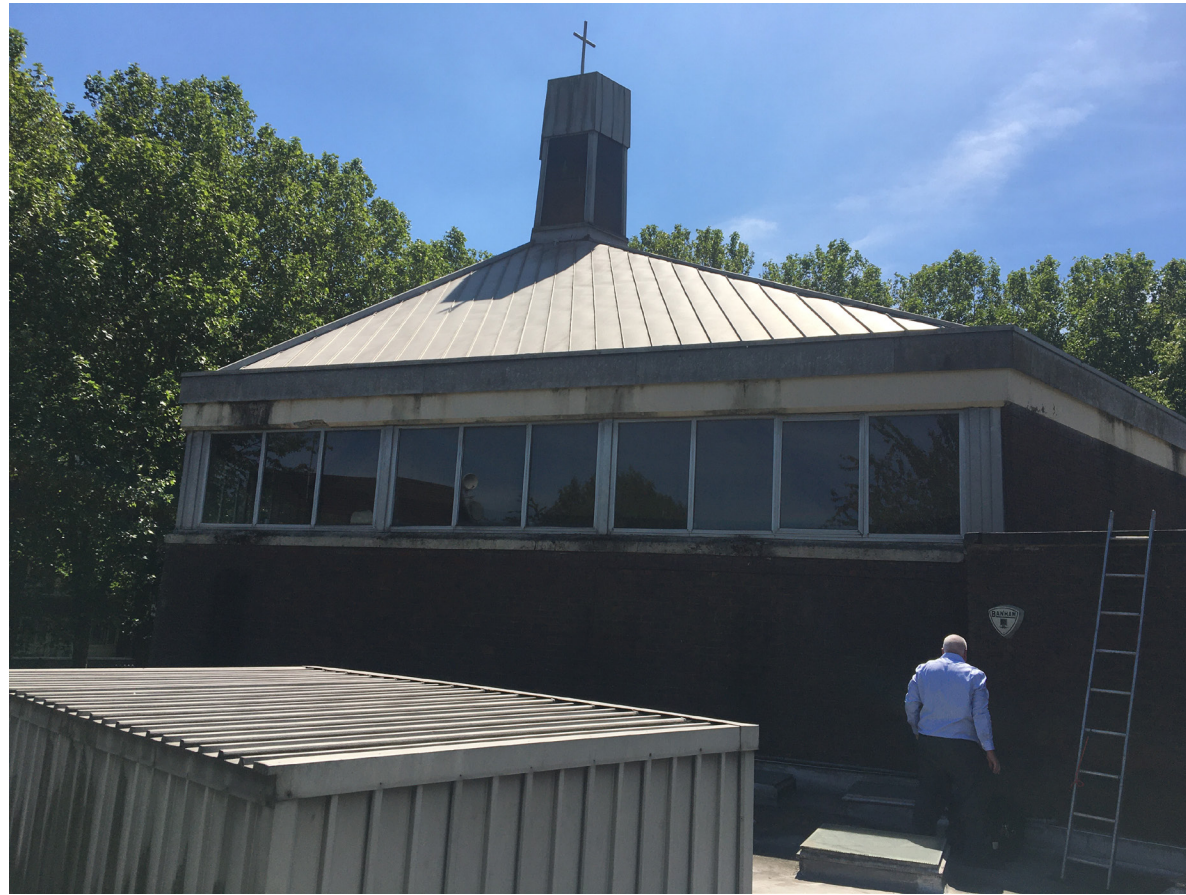
However the condition of the fabric of the main ring beam carrying the roof is poor, due to exposure to water run off from the gutter. In the medium term future (10-15 years) the fabric failure could lead to structural failure. The potential failure of this structural member is due to the surface exposure of the steel reinforcement which has followed long periods of rain water exposure due to the failure of the gutter and rainwater systems.

The ring beam shows signs of water damage and concrete spalling exposing the steel reinforcement

A proposal for concrete repair should ensure the prolonged life of the structure, but only if the design of the gutter and rainwater collection is also addressed. See below for a proposed modification of the gutter design in association with external rainwater downpipes and upgraded external cladding and insulation.

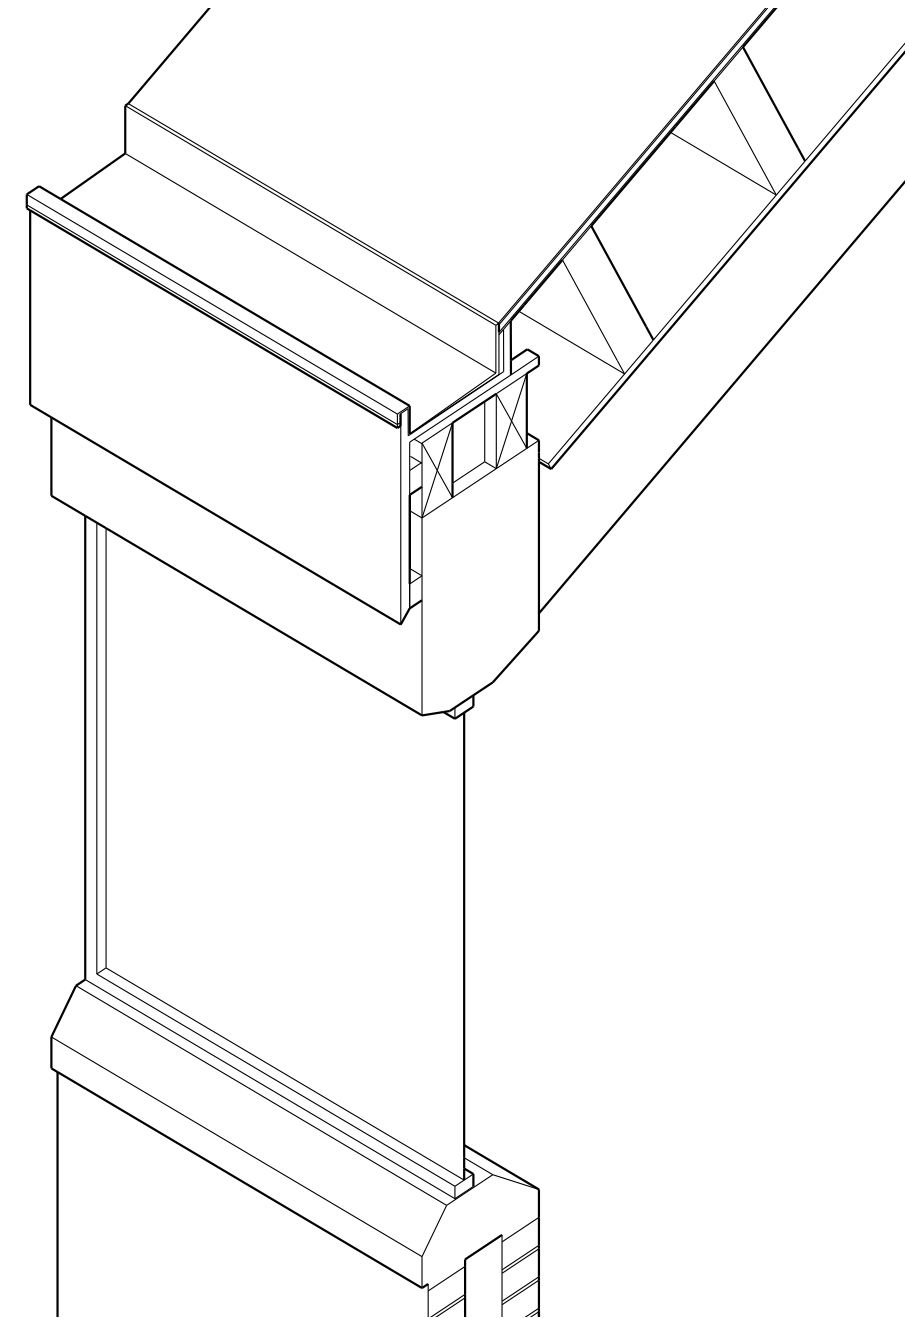
Clerestory window detail showing relationship of concrete frame to the gutter

The concealed gutter is fronted by an asbestos fascia. Four outlets at the North, South, NE and SW angles of the structure. The outlets are insufficient to take the volume of water in a downpour.

The Rainwater outlets are connected to rainwater down pipes encased between the concrete columns with no access or rodding points.

This is a fundamental design flaw that cannot be rectified by increased maintenance

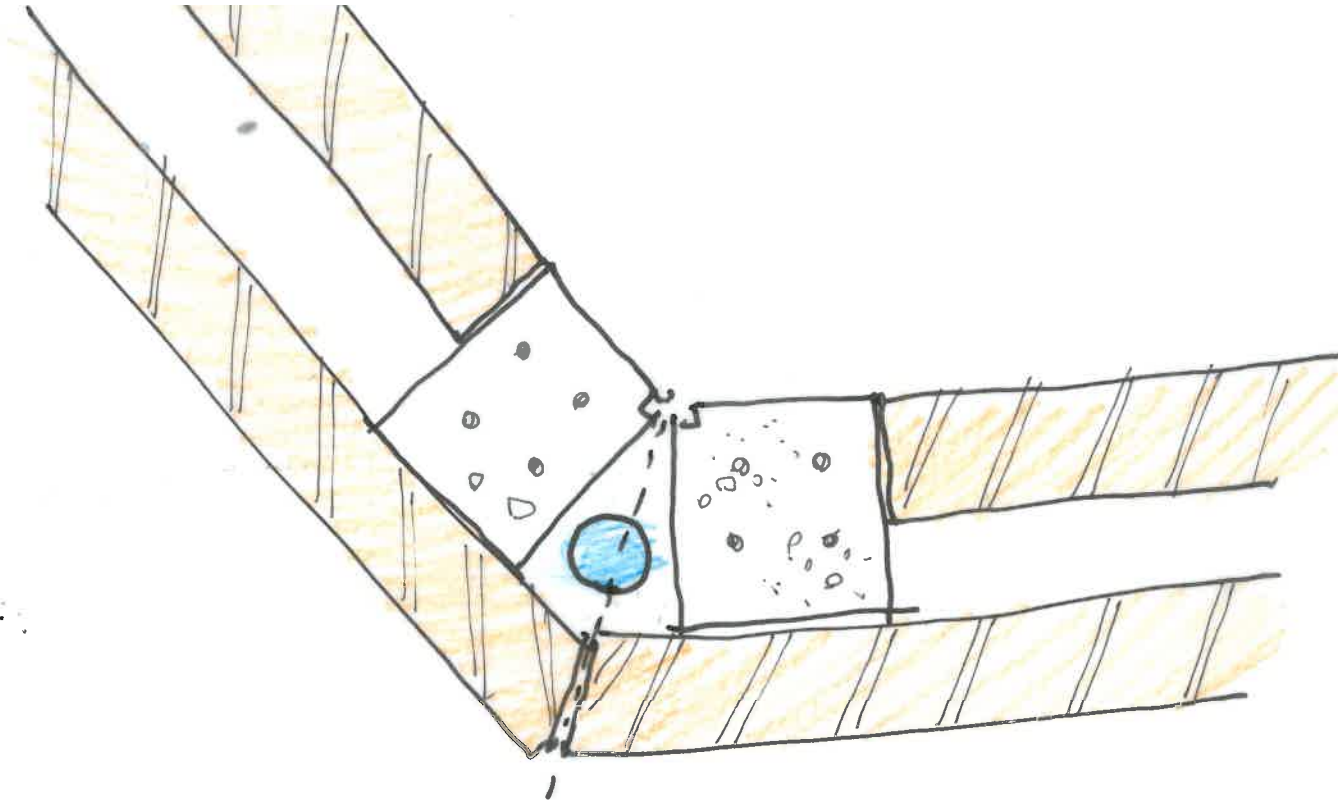
Plan of the existing external wall to the church. The concrete columns intersect the cavity wall on the inner elevation. This creates a cold bridge that contributes to poor thermal performance and high heating bills

The position of the rainwater downpipe is indicated enclosed by the concrete structure. There is no access to the RWP to the below ground drainage system or at upper levels.

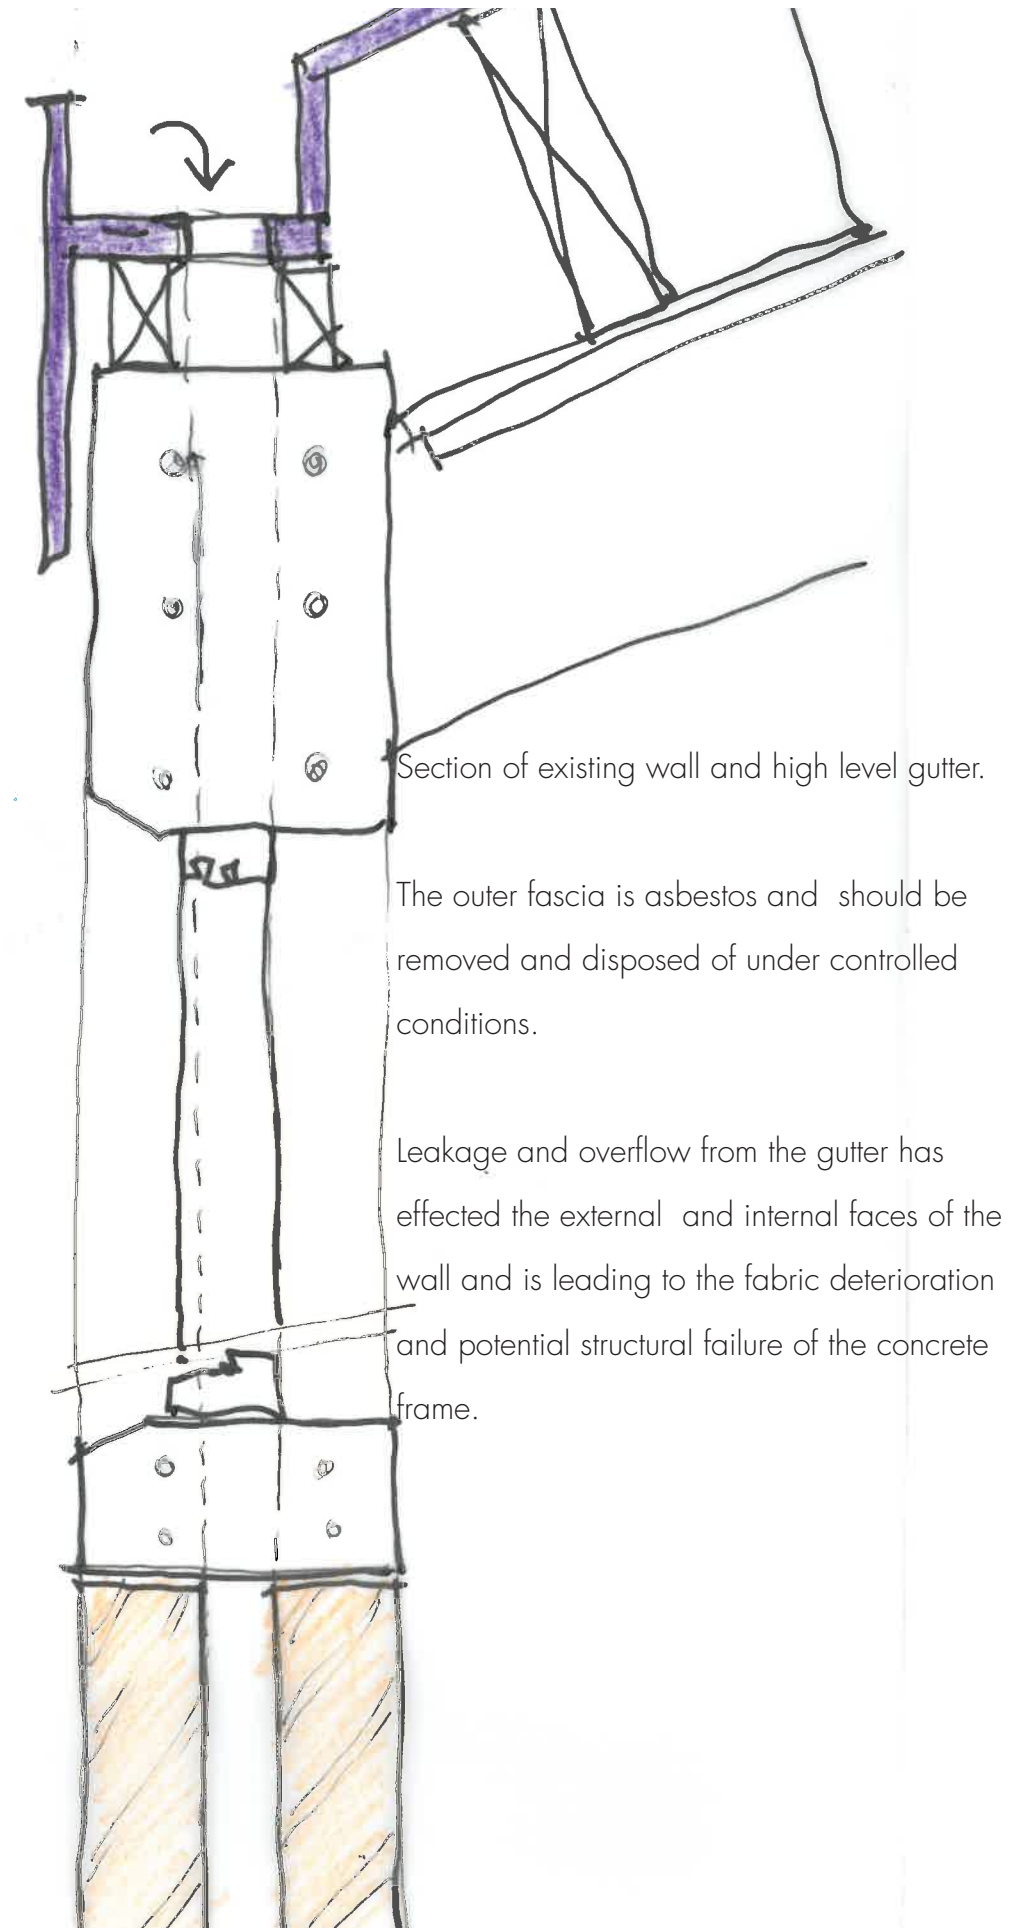
Section of existing wall and high level gutter.

The outer fascia is asbestos and should be removed and disposed of under controlled conditions.

Leakage and overflow from the gutter has effected the external and internal faces of the wall and is leading to the fabric deterioration and potential structural failure of the concrete frame.

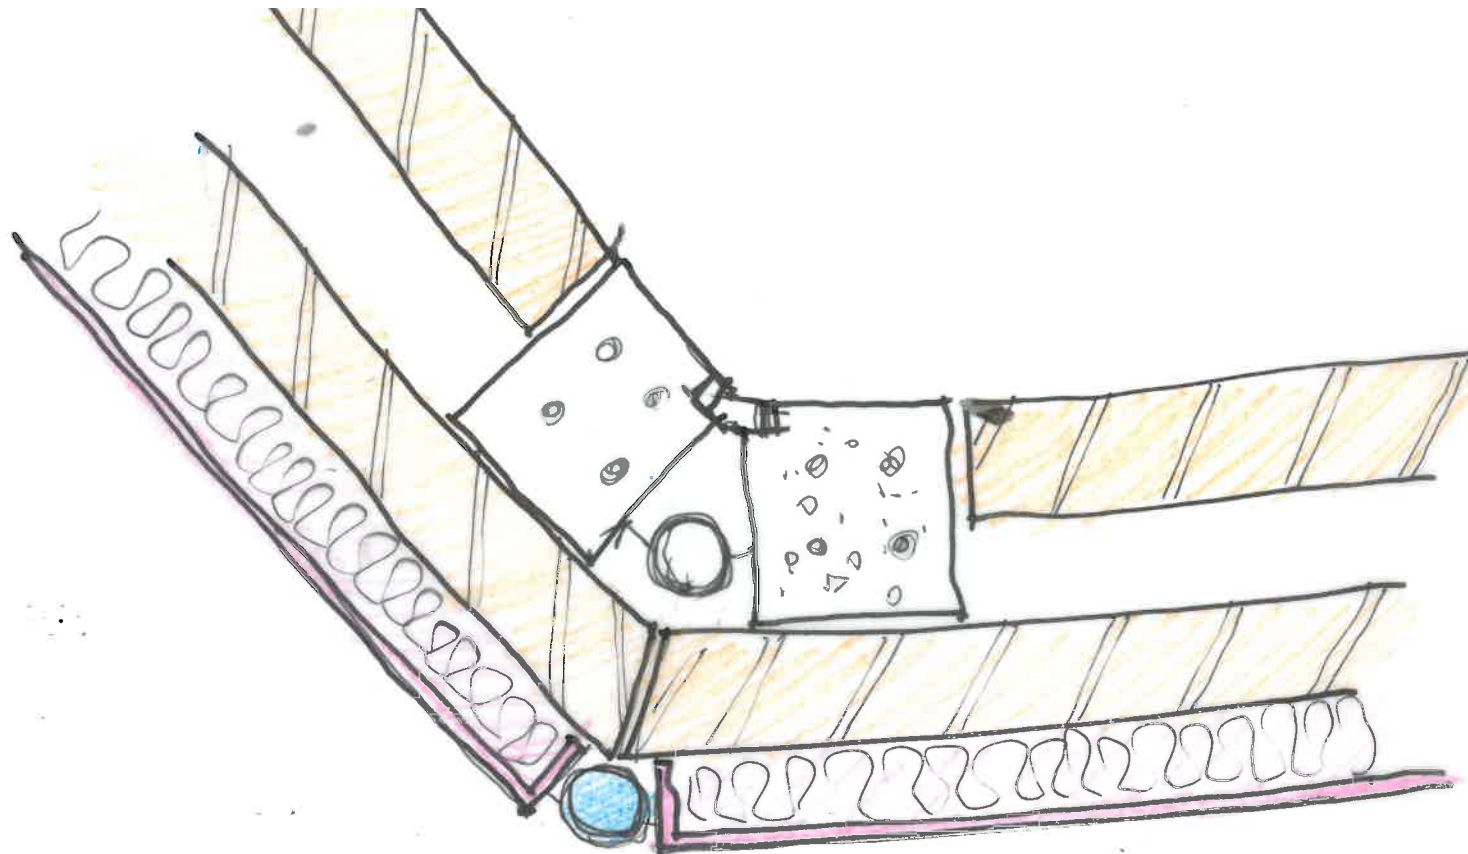
Sketch plan of the proposed external wall to the church. The 4 rain water downpipes are replaced by an enlarged gutter system on the outside of the existing external wall. These new rainwater pipes will be carefully designed and fabricated in aluminium to match the appearance and aesthetic of the church building. They will be connected to roddable gullies in to the existing below ground drainage system.

The appearance and thermal performance of the building could also be enhanced by an additional fabric insulated rain-screen cladding which would integrate the down pipes into the external fabric.

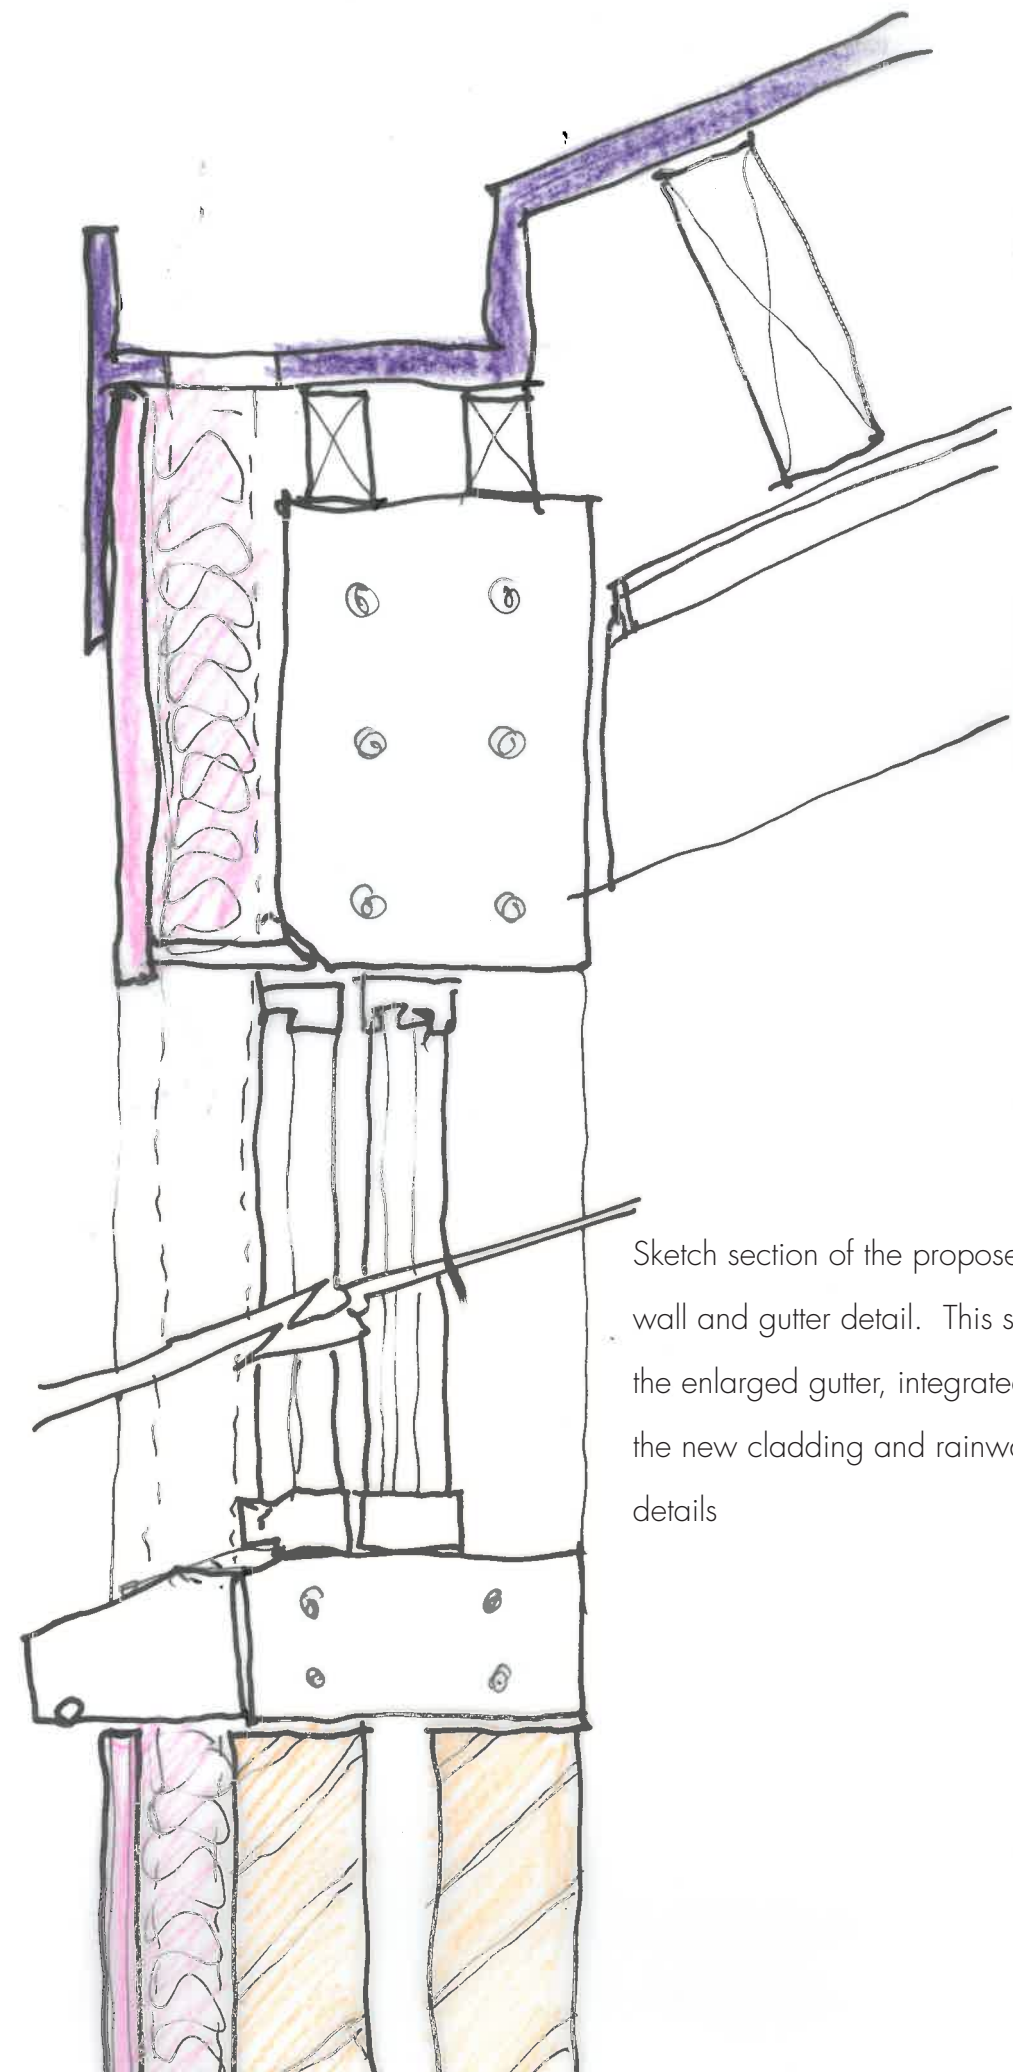
Sketch section of the proposed outer wall and gutter detail. This shows the enlarged gutter, integrated with the new cladding and rainwater details

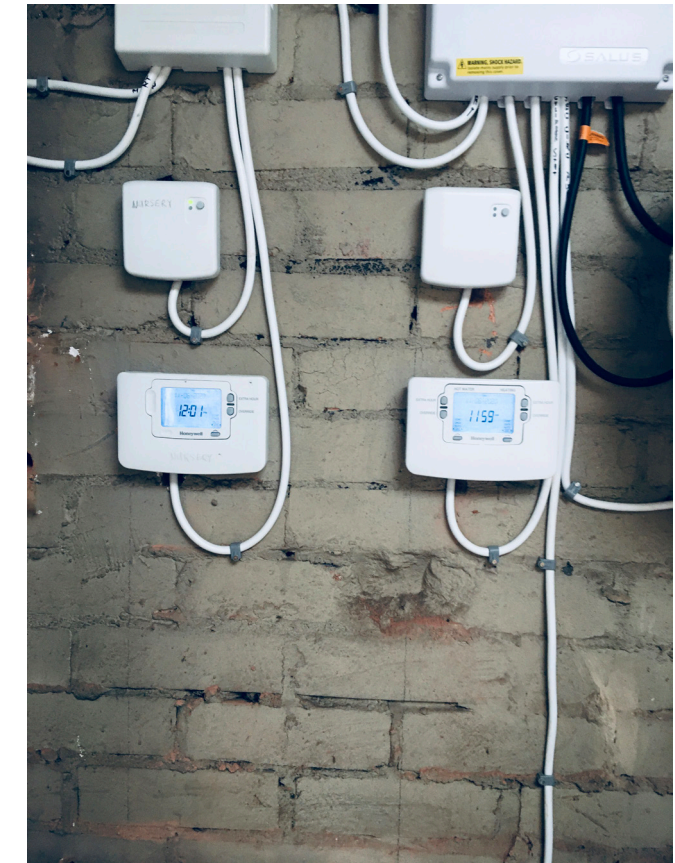
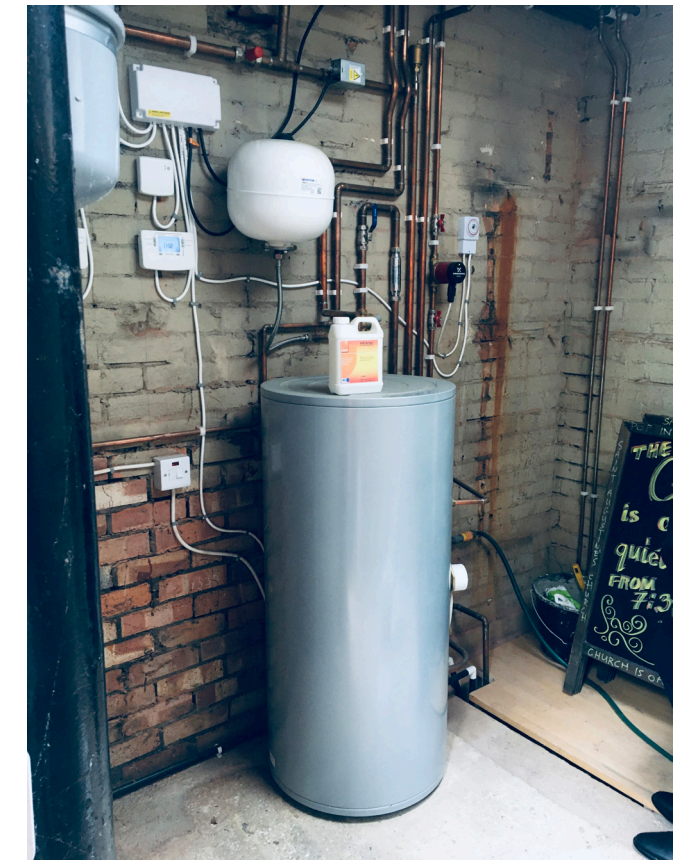
The heating is new throughout the church and the gas fired heaters are in a good condition. The pipes within the plant room and areas that the public can reach require lagging and boxing in for health and safety reasons.

New boiler installed in 2016
