St Augustine's Church Survey Report

Grahame Park

3.1 Structure and Concrete survey

This inspection was carried out on 20th May 2020. Concept Consultancy. John Brown. See Appendix 1.

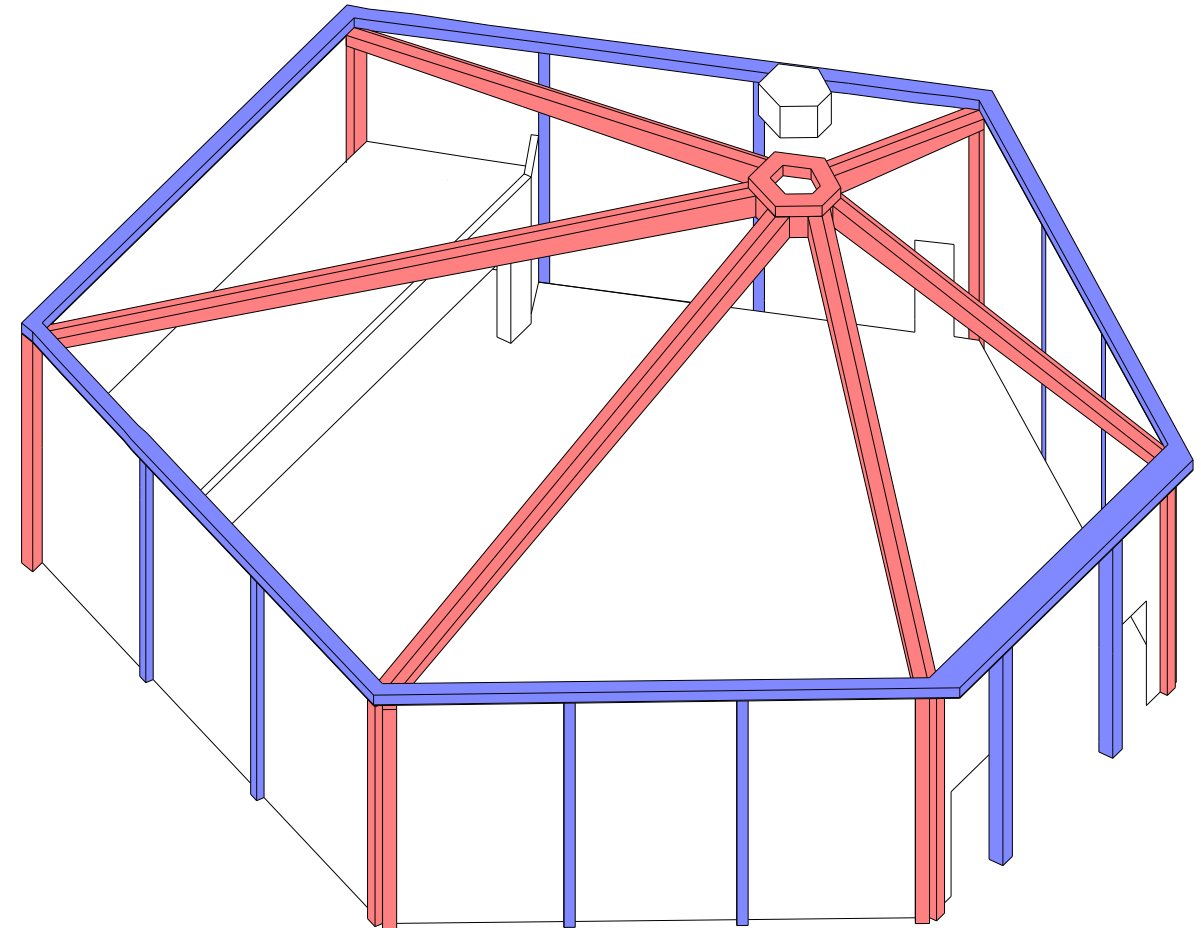
The main ring beam on the SW corner. The discoloured concrete indicates overflowing gutters and has led to spalling fabric and exposure of the steel reinforcement

The ring beam shows signs of water damage and concrete spalling exposing the steel reinforcement

"The carbonation, sulphate and chloride results were all very low which is good. There was only one instance where the carbonation was greater than the reinforcement cover. The main issue with the beams is low cover. However this is localised to small areas. The water run off from the roof is coming down edge of the beams in several locations. This is where the steel corrosion is worse. The Survey recommend that the roof and drainage design is modified so that the water run off can be directed away from the beam edge.

However the condition of the fabric of the main ring beam carrying the roof is poor, due to exposure to water run off from the gutter. In the medium term future (10-15 years) the fabric failure could lead to structural failure. The potential failure of this structural member is due to the surface exposure of the steel reinforcement which has followed long periods of rain water exposure due to the failure of the gutter and rainwater systems.

We would also recommend that any spalling concrete is removed and the reinforcement treated. The concrete can then be repaired with a suitable repair mortar. The structure of the building is a cast in-situ concrete frame. The main building is based on an irregular hexagonal frame with columns at each corner carrying the cill beam to clerestory windows, and roof beam at eaves level above. Intermediate columns are expressed internally on the inner panels.

We would recommended contacting Sika. They can specify a specification and what repair materials are most suited. "

A proposal for concrete repair should ensure the prolonged life of the structure, but only if the design of the gutter and rainwater collection is also addressed. See below for a proposed modification of the gutter design in association with external rainwater downpipes and upgraded external cladding and insulation.

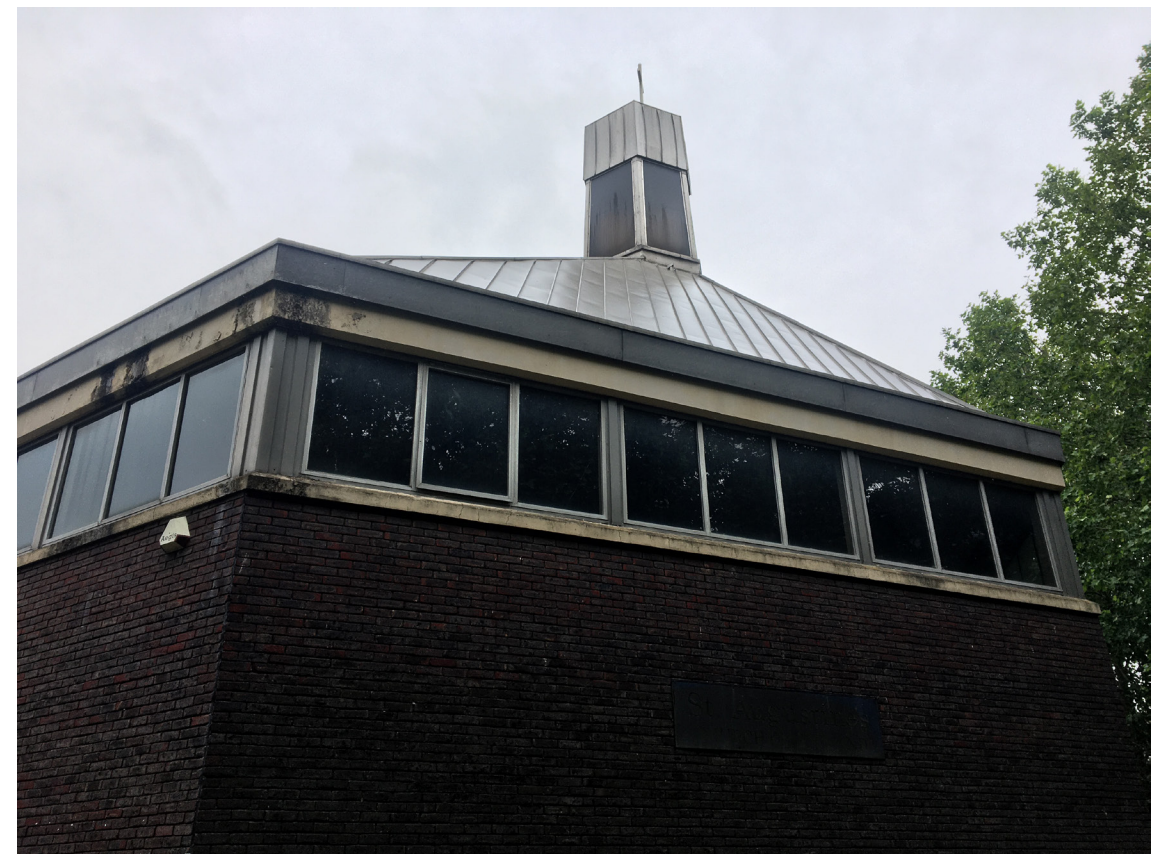
The ring beam shows signs of water damage and concrete spalling exposing the steel reinforcement

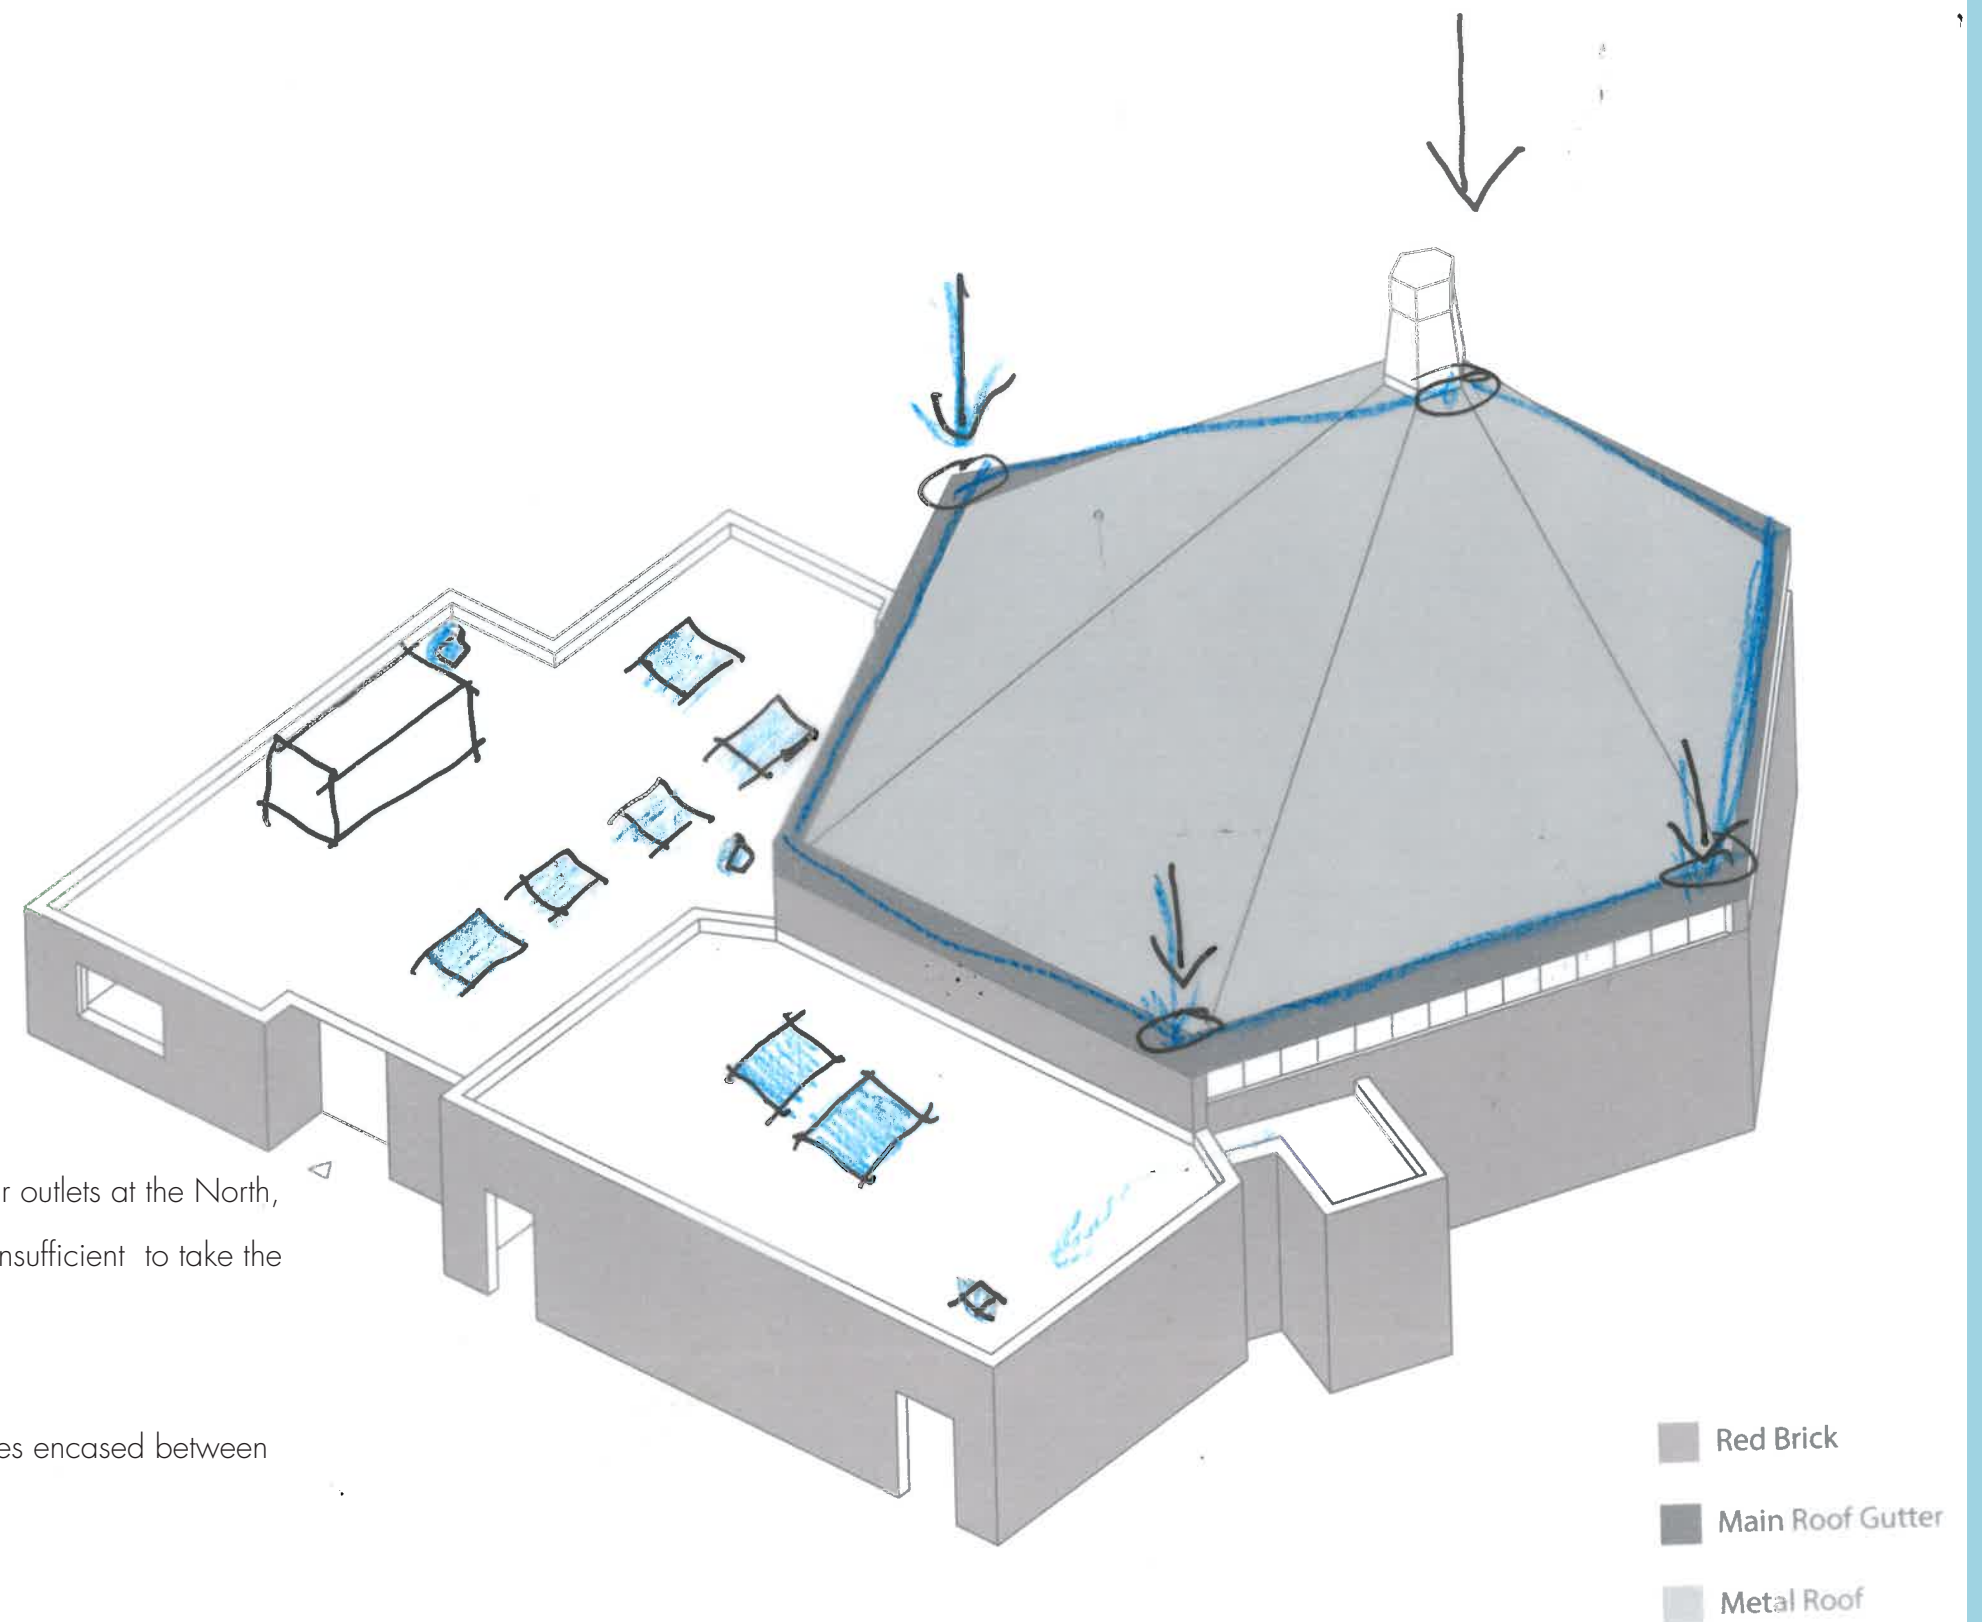
The Rainwater outlets are connected to rainwater down pipes encased between the concrete columns with no access or rodding points.

This is a fundamental design flaw that cannot be rectified by increased maintenance

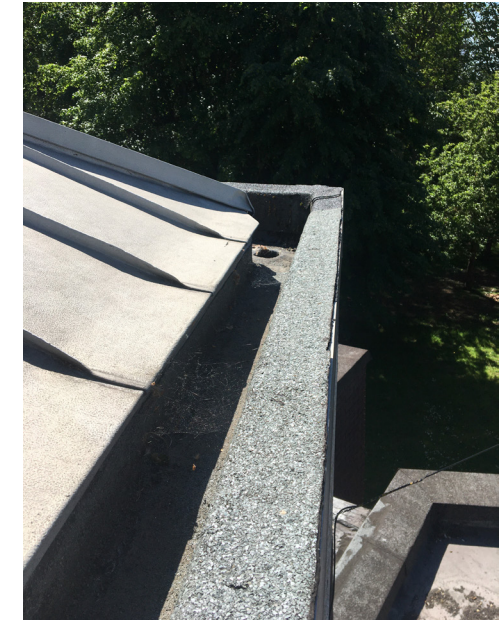
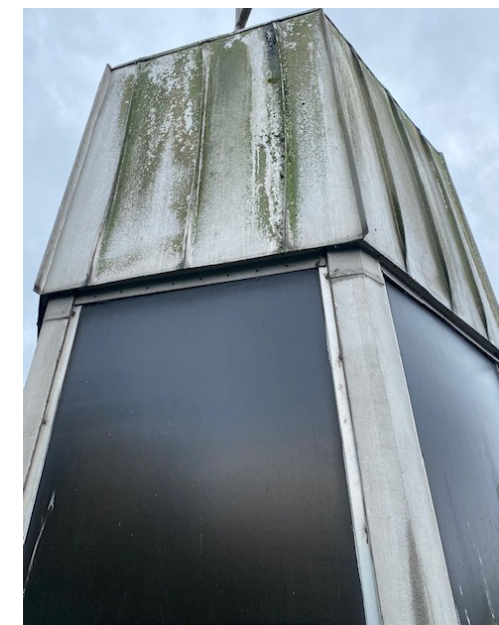
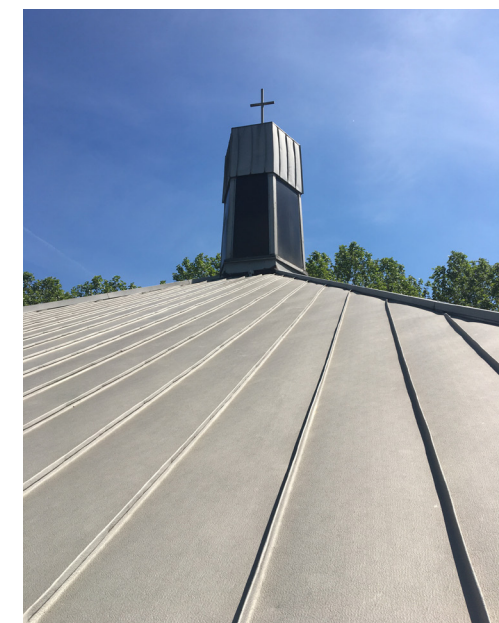
Sketch details of structure, fabric and gutter

The gutter to the main roof is the most significant failure in design and which has contributed to the long term deterioration of the structural frame. The gutter is both too small to cope with the quantity of water in a down fall, and has only four outlets connecting to internal rain water pipes hidden within the wall between the columns. There are no access or rodding points and blockages at the lower levels are hidden and inaccessible. The gutter has been relined with roofing felt, but this has not addressed the underlying issue of design failure that has led to overflow and leakage, causing staining to the brick works and deterioration to the concrete frame. The outer fascia of the gutter is formed from asbestos sheeting. Thus repairs and/or replacement of the gutter will need to address the issue of asbestos removal and replacement of the outer fascia.

The outer fascia is asbestos and should be removed and disposed of under controlled conditions.

Leakage and overflow from the gutter has effected the external and internal faces of the wall and is leading to the fabric deterioration and potential structural failure of the concrete frame.

However a simple repair will not be enough. The gutter should be reformed to create a wider gulley with additional outlets, and rainwater down pipes installed with access for rodding. The best detail will be to install down pipes on the external fabric of the building, simulataneously inslatilling a thermally enhanced rain screen cladding.

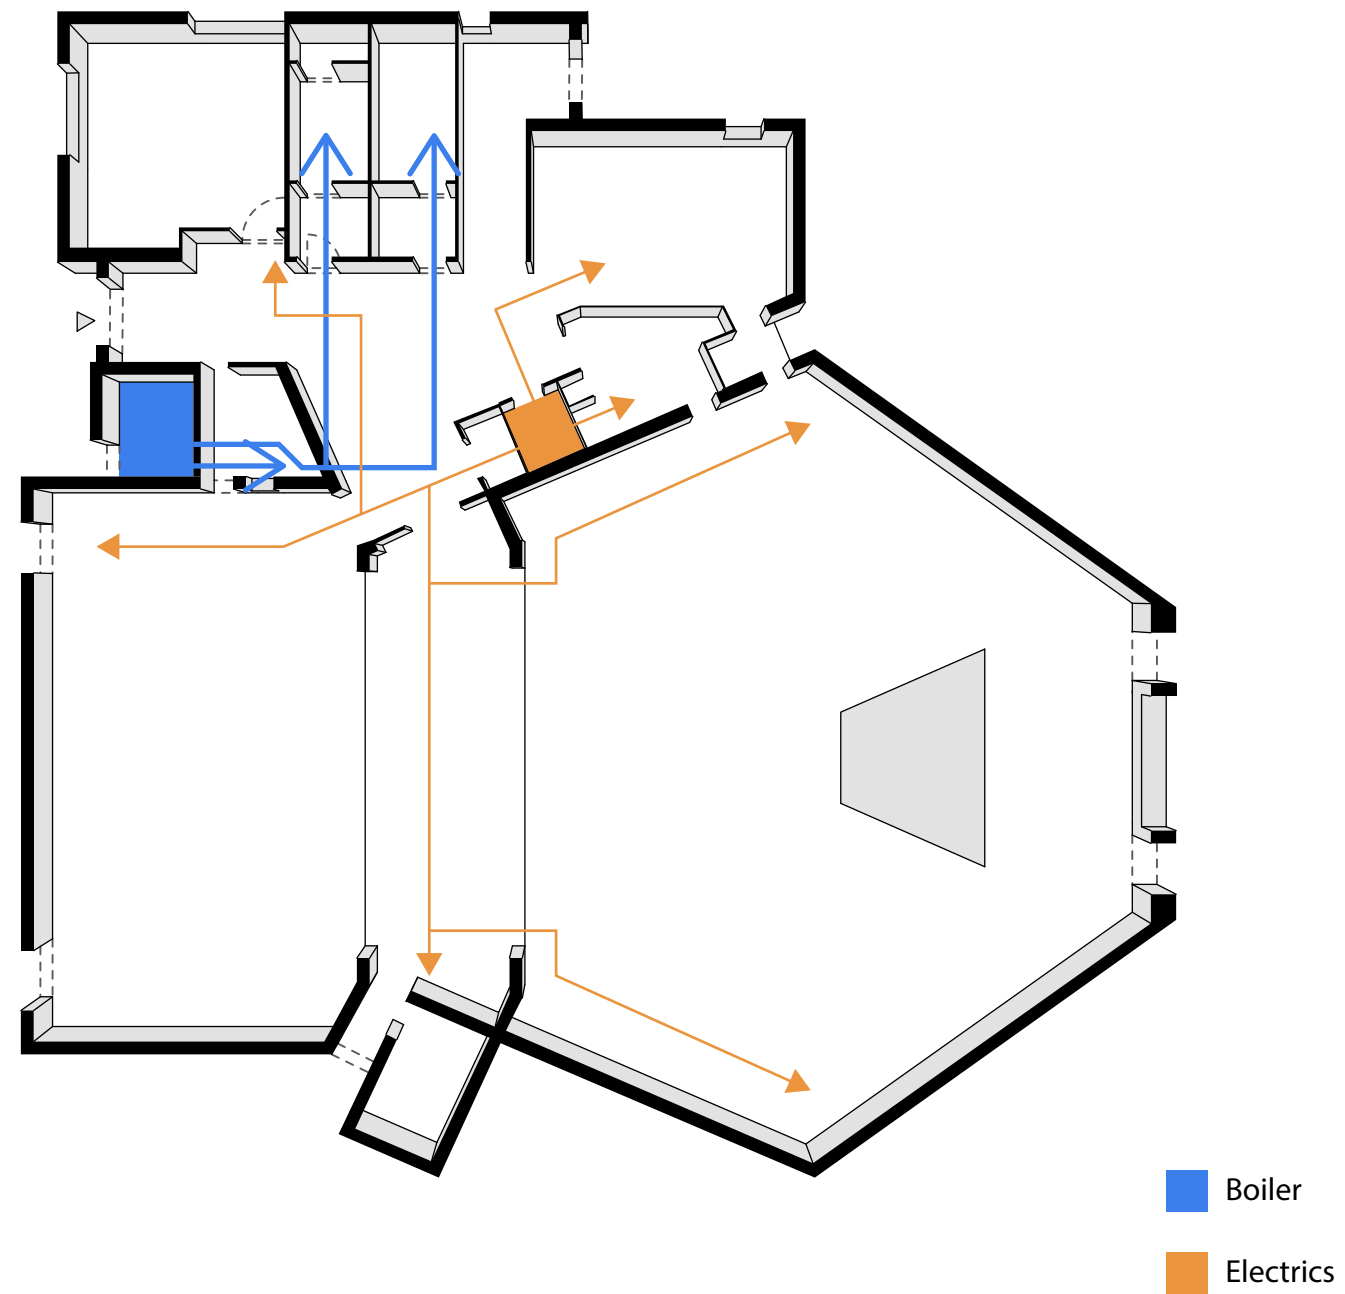
Services Layout of the Ground floor

The electrical installation is over 30 years old and in a poor condition. We would recommend a complete new rewire of all the church from new consumer units and new complete testing and renewing circuits, along with cables and fittings to bring the installation up to the current IEE Regulations and British Standards. Also to give adequate amount of outlets required for the modern church and its uses.

The heating is new throughout the church and the gas fired heaters are in a good condition. The pipes within the plant room and areas that the public can reach require lagging and boxing in for health and safety reasons.
